# Manhole Inspection Summary

Manhole # S13II\_012MH

Insp Date: **2/26/08 3:35 PM**

**Location** Address: **1737 POPLAR GROVE ST**

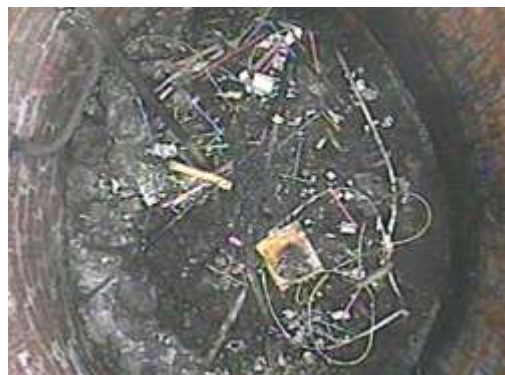
Top View

Condition: ☐ Sound ☐ Cracked ☐ Root Intrusion ☐ Deteriorated ☐ Leaks ☒ **Debris**

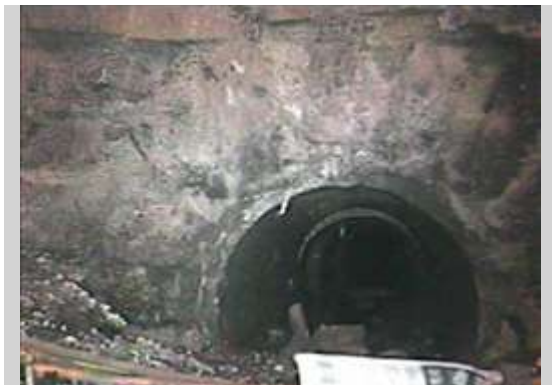
12 O'Clock Outflow

8 in. Circular Gravity Sewer  
Pipe Out @ 12 O'Clock

Deposits: ☐ None ☐ Mud ☐ Sludge ☒ **Debris** ☐ Grease

Silt Depth: **2** (in.) Deposits Extent: **Light**

Infiltration: **None** Pipe Seal Cond: **Sound**
